**Chile-China Workshop**  
 Research on Natural Disasters  
 26 August 2016

**Landslides and Mudflows**  
**in the Chilean Andes**

**Sergio A. Sepúlveda,**  
 Universidad de Chile

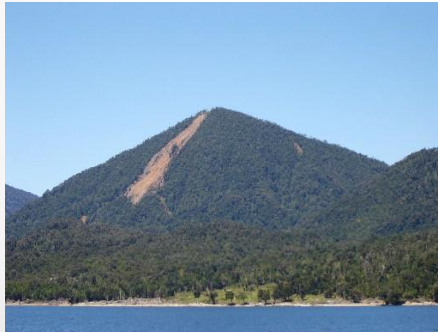
## Earthquake-triggered landslides

- Disrupted, shallow soil and soil-rock slides

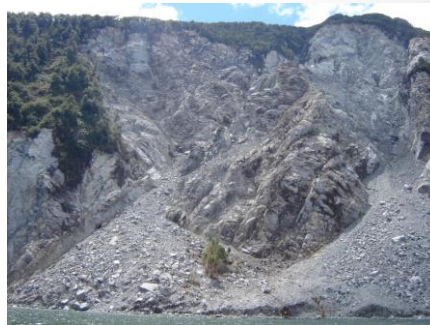
- Massive rock slides

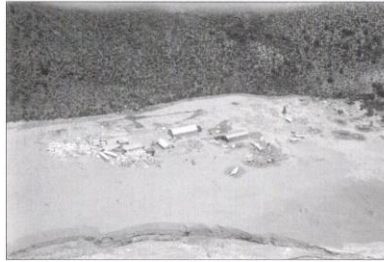
Figure 9. Aerial view of La Paloma Camp (for location see Fig. 2) 10 days after event showing damage to buildings and machinery. Debris flow claimed at least 37 lives at this site in Rio Colorado valley. Downstream is to right.

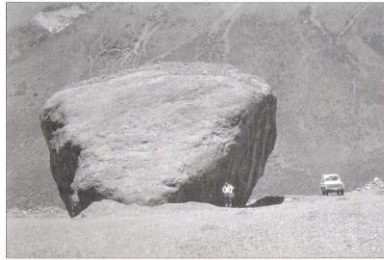
Figure 10. Huge ~2700 t boulder moved 11.0 km by debris flow in Rio Colorado from Parraguire-Colorado confluence (see Fig. 2 and Fig. 11).

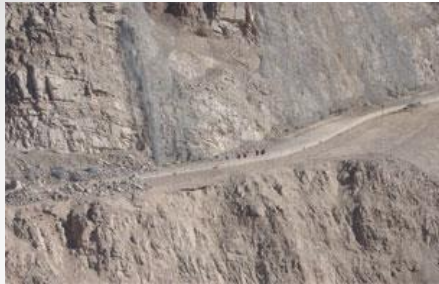
Tarapacá earthquake 2005 (Mw 7.8, intermediate depth intraplate). Landslides along coastal route and inland rural and mining roads.

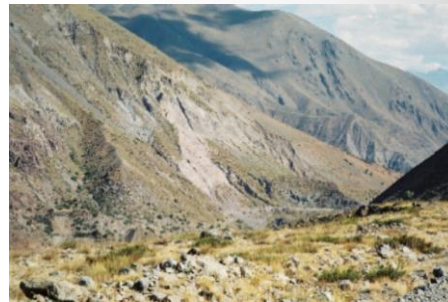
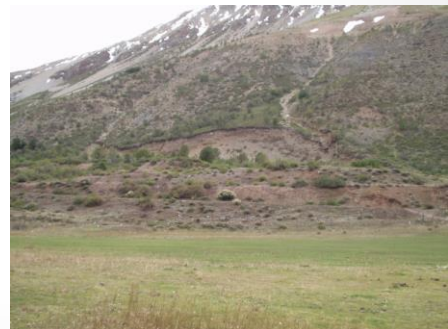
- Plenty of rock falls in the epicentral area.
- Two soil slumps were triggered, both well preserved until now.
- Las Cortaderas (Yeso Valley, ca. 15 Mm<sup>3</sup>) and El Manzanito (Maipo Valley, ca. 4 Mm<sup>3</sup>).
- Both in zone with est. Intensity over 8

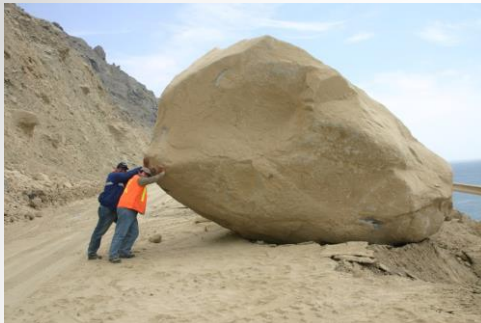
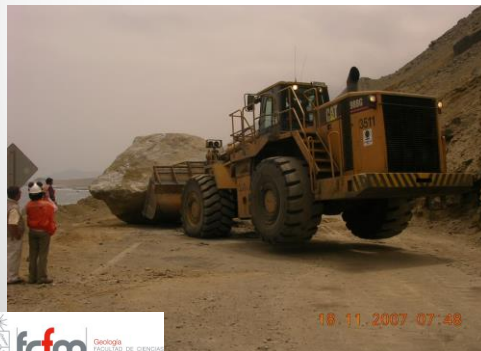
**Tocopilla earthquake, 2007**  
Route 1

- Rock falls and localized shallow rock and soil (colluvium) slides along the coastal cliff.
- Main damage to coastal highway.
