Water in Chilean Patagonia: Key Resource...and Geohazard

Recent and Ongoing Investigations

Dr. Alejandro Dussailant

Director of Research, Universidad de Aysén, Chile

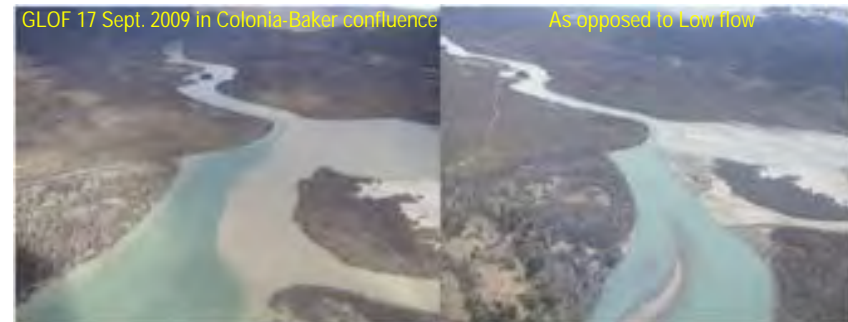
GLOF 17 Sept. 2009 in Colonia-Baker confluence

As opposed to Low flow

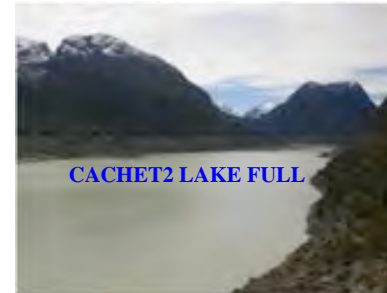
CACHET2 LAKE FULL

- $L \sim 5 \text{ km}$, $W \sim 1 \text{ km}$, $D \sim 50 \text{ m}$
- GLOFs: $\sim 200 \text{ Hm}^3$

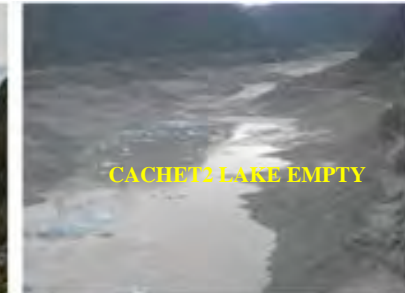
CACHET2 LAKE EMPTY

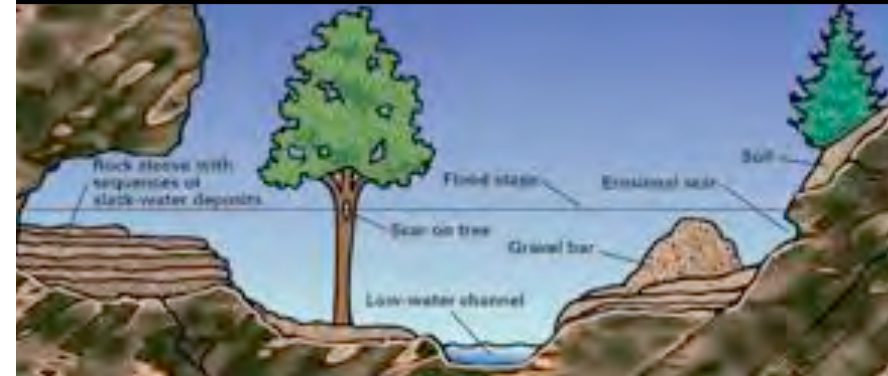
Geomorphological Indicators to identify water levels

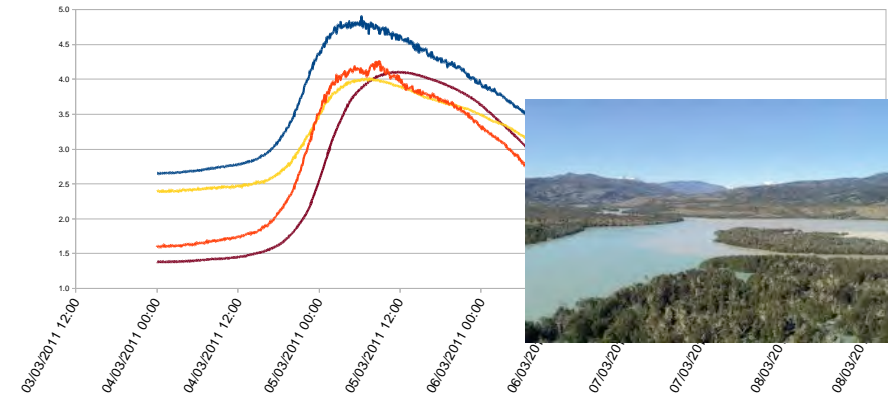
Water level sensors along Río Colonia: GLOF 5 Mar 2011

- 5 Mar 2011: wave 1.6-2.7 m, velocity 0.6-1.6 m/s
- Other outburst flood waves: >4m and >2m/s

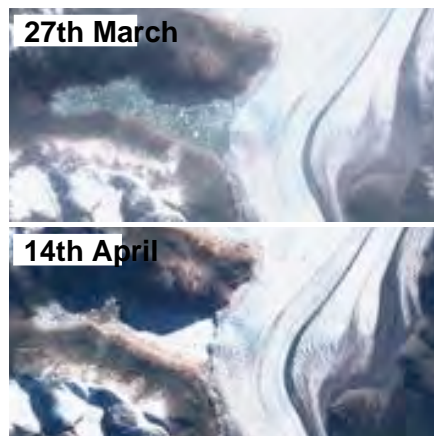
March 27th 2017 GLOF

(2nd of season – smaller, with approx 7 m level increase)

Lake drained
in ~48 hours

Lake area ~11 km^2
(volume ~250 Hm^3)

ESA Sentinel 1 satellite imagery

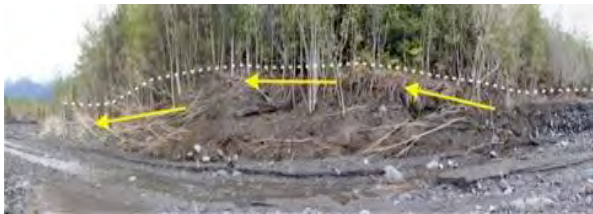
Lahar erosional impacts

- Erosional trimlines
- Streamlined morphologies
- Bedrock plucking
- Superelevation

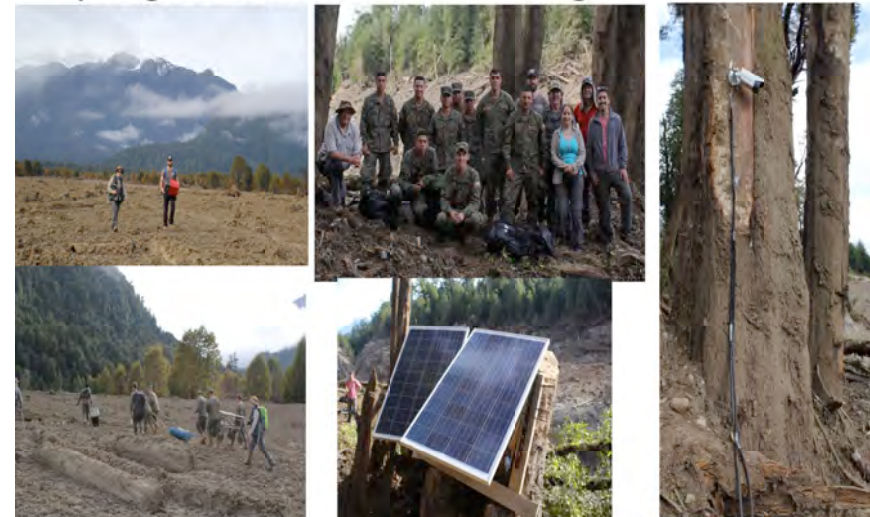
#PatagoniaSensors @VSL (Jan 2018)

Equipment installed: non-contact hydrometric monitoring station, consisting of: (i) 2 x 100W solar panels; (ii) 1 x 200Ah 12v battery; (iii) Raspberry Pi Model 3 equipped with Arduino header and 3G/GRPS modem on mobile network; (iv) a 12v powered Hikvision IP camera with near-infrared sensing, connected to R-Pi via ethernet cable.

- Videos of 10s & battery voltage at 5-min intervals (sent to the Amazon S3 cloud)
- Laser scan survey at monitored reach to calculate morphological properties of the cameras field of view e.g. width, wetted area, water surface slope
- Coming soon: (i) river level; (ii) water surface velocities; (iii) estimation of river discharge
